# Home Inspection Report

**Report Number: 231-2015**

1976 Pilgrims Way  
Boone , North Carolina

Date of Inspection: Friday, April 1, 2016

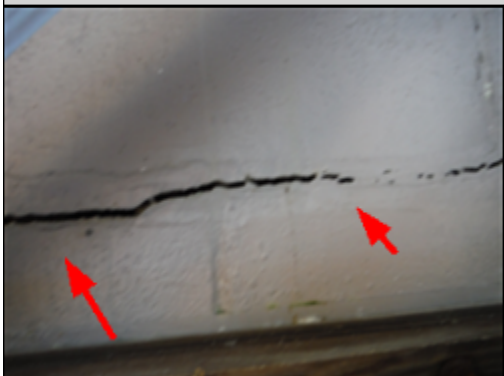
#### (A1 - 1.1 ) Main House

The foundation wall located on the left side the home has cracked in the horizontal direction and is trying to buckle into the foundation area. Horizontal cracks are the most serious cracks in foundations that are earth retaining because the walls can buckle without warning and jeopardize the structure of the home. An engineer should be consulted for a complete evaluation, to determine the significance of the concern and outline necessary repairs.

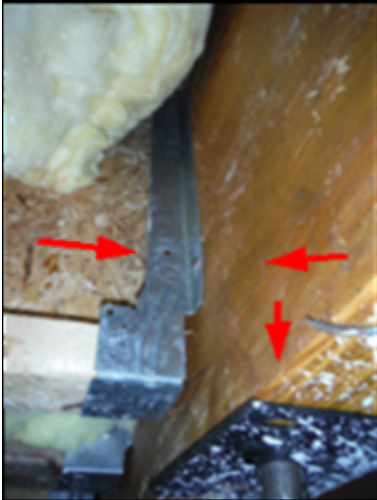
Engineered hangers used to support the ends of (I-Joist) floor joist are not attached properly. Several of the hangers were found to have nails that were bent over or attachments had missing nails. The metal hangers used to support the floor joists of the floor structure were installed without web stiffeners to fill the gap between the joist and hanger and to provide proper bearing for the hanger. Proper bearing/proper nailing is crucial to the function of the hanger, without proper installation the hanger attachment could weaken the floor system or cause it to fail. Web stiffeners fill in the gap between the hanger and the web and provide support for the I-joist along the vertical axis. It is beyond the scope of the home inspection to determine the type or brand of the I-Joist or if web stiffeners were required on this installation. Also, it was observed that the steel post do not have any nails or screws at the top securing them to the girder. A licensed general contractor should be consulted for complete evaluation of the floor system and to make necessary repairs.

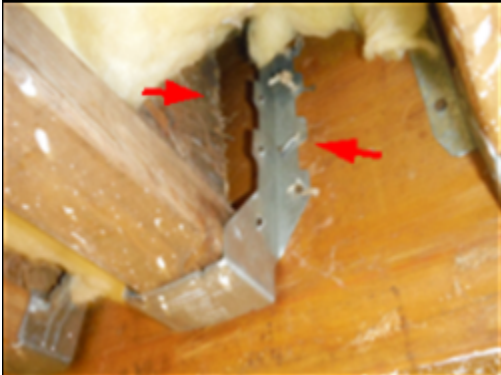
<b>(A3 - 1.2 ) All Accessible Areas</b>

-nails bent over not driven in completely or missing nails /no web stiffeners
<b>(A3 - 1.3 ) All Accessible Areas</b>

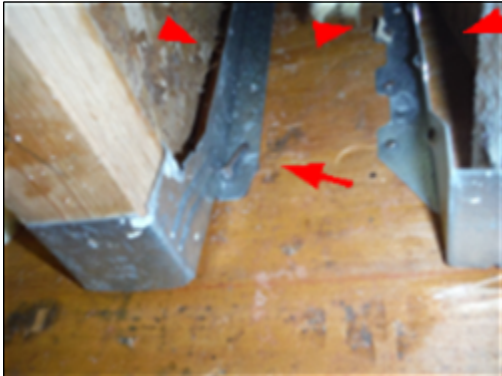
-nails bent over not driven in completely or missing nails /no web stiffeners

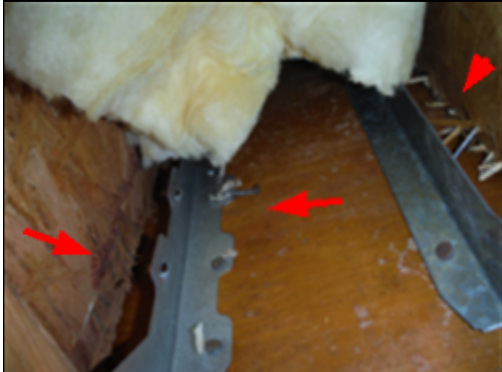
**(A3 - 1.4 ) All Accessible Areas**

-nails bent over not driven in completely or missing nails /no web stiffeners

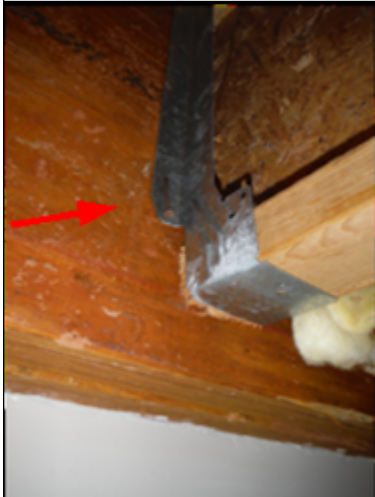
**(A3 - 1.5 ) All Accessible Areas**

-nails bent over not driven in completely or missing nails /no web stiffeners

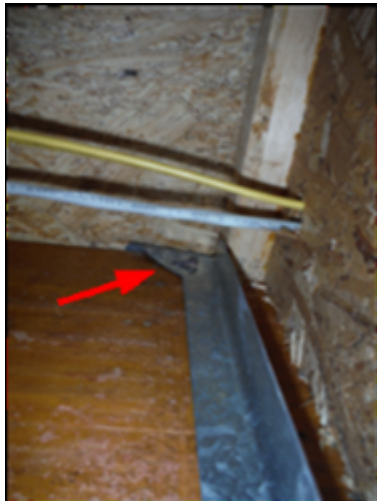
**(A3 - 1.6 ) All Accessible Areas**

-nails bent over not driven in completely or missing nails /no web stiffeners

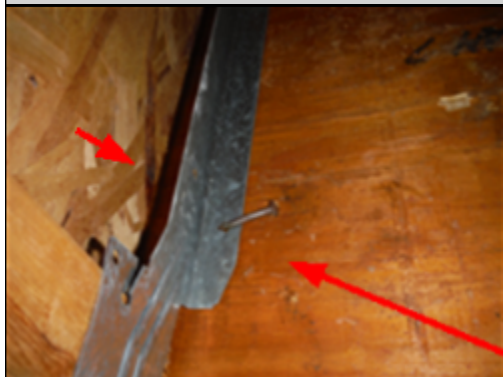
**(A3 - 1.7 ) All Accessible Areas**

-nails bent over not driven in completely or missing nails /no web stiffeners

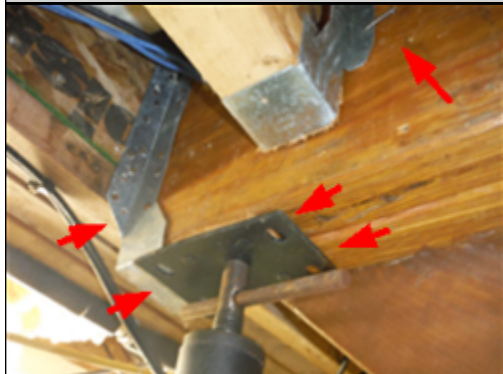
**(A3 - 1.8 ) All Accessible Areas**

-nails bent over not driven in completely or missing nails /no web stiffeners/top of support post not nailed or screwed into girder

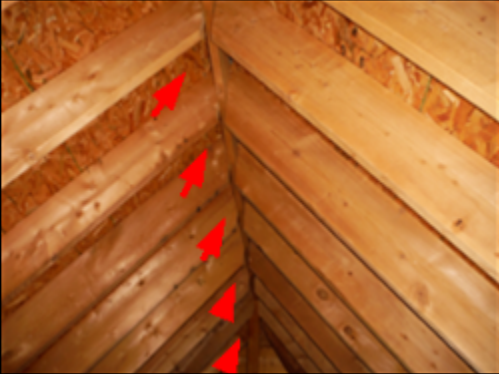
From the attic of the home, the roof ridge board is not sized to provide a full contact bearing for the rafters. When the ridge board is not full depth to the rafter cuts, the rafter is not supported at the heel and can crack or split. Also, some of the cuts show a gap between the rafter and the ridge board. When the heel of the rafter is not supported by the ridge board the load is concentrated on the toe of the rafter cut. This same condition was observed on engineered (LVL) beams used for valley rafters. A licensed general contractor should be consulted for a full evaluation of the roof system and to make the necessary repairs.
<b>(A6 - 1.2 ) Main House</b>

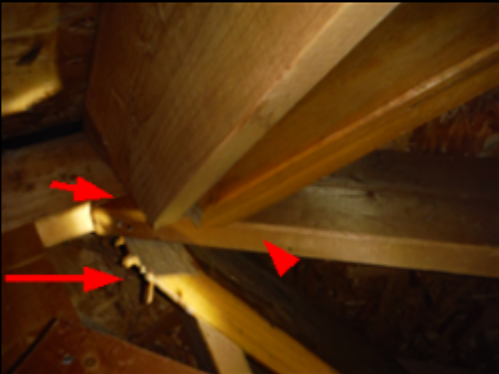
-ridge board not full depth/ Engineered LVL beam (valley rafter) not bearing on ridge board properly

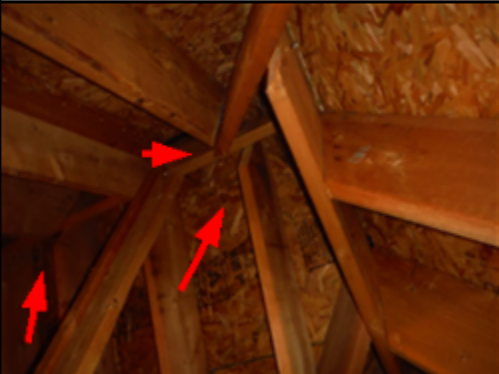
<b>(A6 - 1.3 ) Main House</b>

-ridge board not full depth
<b>(A6 - 1.4 ) Main House</b>

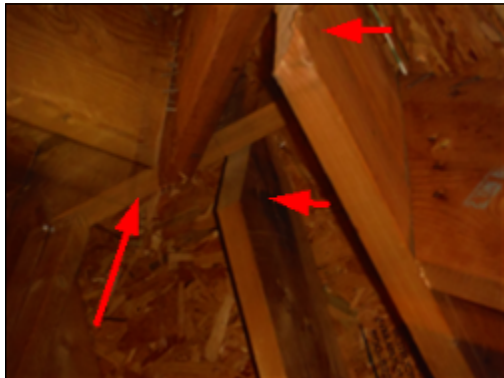
-ridge board not full depth/gap at rafter cut

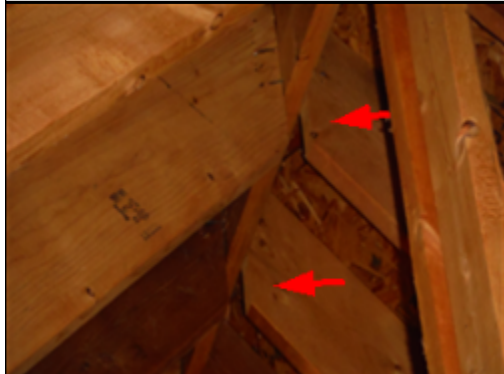
**(A6 - 1.5 ) Main House**

-ridge board not full depth

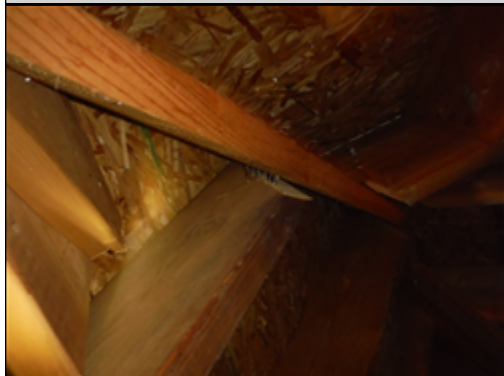
**(A6 - 1.6 ) Main House**

-ridge board not full depth/gap at rafter cut

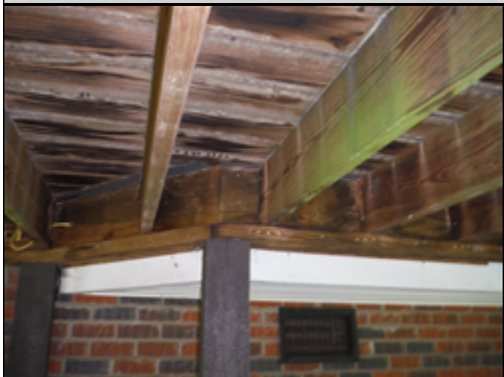
At the section of deck attached to the bay window the deck anchor bolts are not visible and could not be verified. There are post attached under this deck band that may be being used instead of an anchor /thru bolt. However one of the post is loose at the top and not securely attached to the bottom of the deck. Also, it should be noted that there are no angled bracing on this deck at the post, that would prevent lateral movement. All decks require seasonal maintenance and annual inspections, this is especially important for cantilevered or elevated decks. The buyer should consult a general contractor for further evaluation and repair.

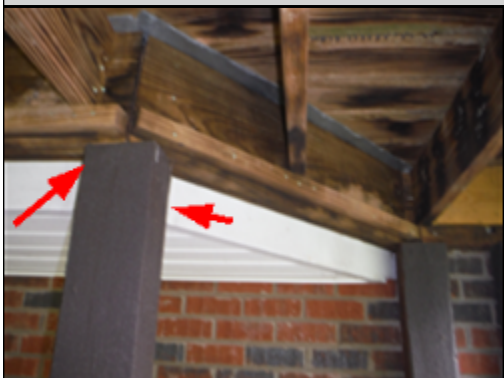
**(B3 - 1.2 ) Deck**

-post is loose at the top under bay window section

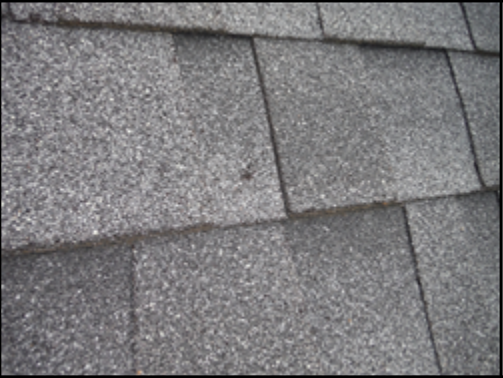
Several shingles on the roof surface were noted to be damaged. The damage appears to be from construction traffic. When the shingle's surface protective ballast is damaged, they can prematurely age, split and crack. A licensed roofing contractor should be consulted for a complete evaluation of the roof covering to replace damage shingles to ensure the durability of the roof covering system.
<b>(C1 - 1.2 ) All Accessible Areas</b>	
 	-damaged shingles
<b>(C1 - 1.3 ) All Accessible Areas</b>

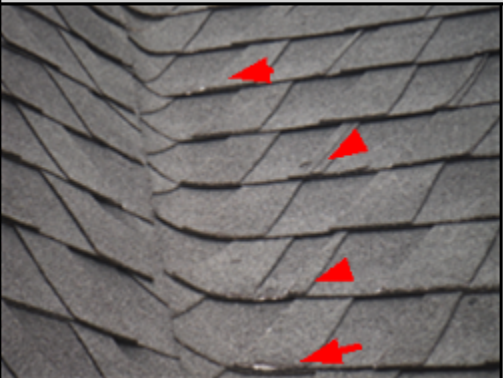
-damaged shingles
<b>(C1 - 1.4 ) All Accessible Areas</b>	
 	-damaged shingles

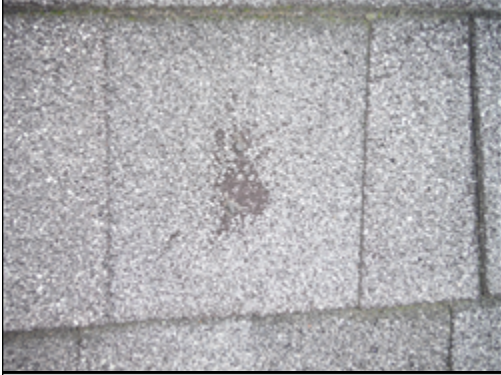
**(C1 - 1.5 ) All Accessible Areas**

-damaged shingle

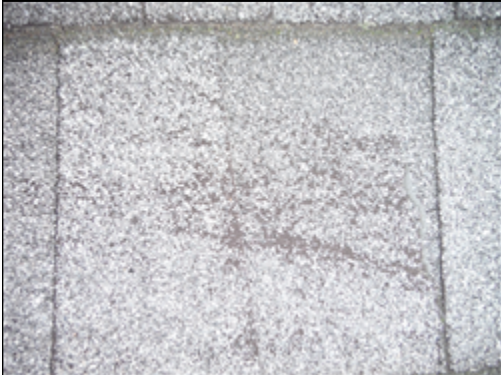
**(C1 - 1.6 ) All Accessible Areas**

-damaged shingle

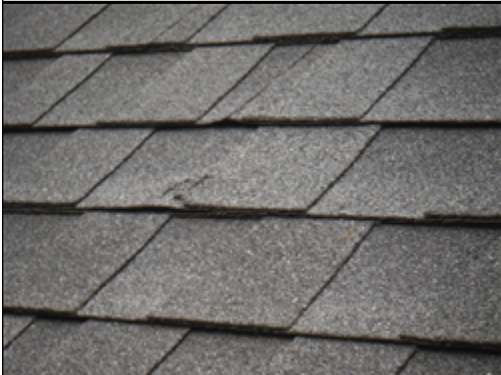
**(C1 - 1.7 ) All Accessible Areas**

-damaged shingle

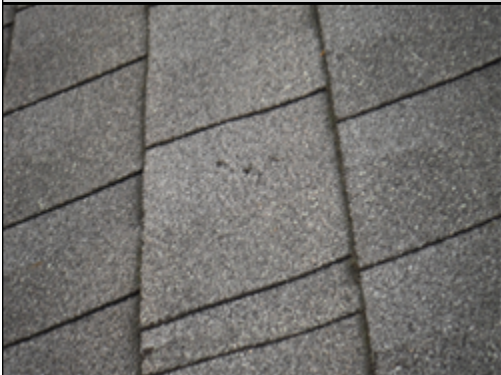
**(C1 - 1.8 ) All Accessible Areas**

-damaged shingle

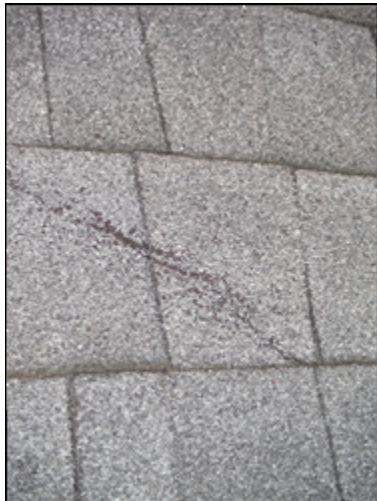
**(C1 - 1.9 ) All Accessible Areas**

-damaged shingle

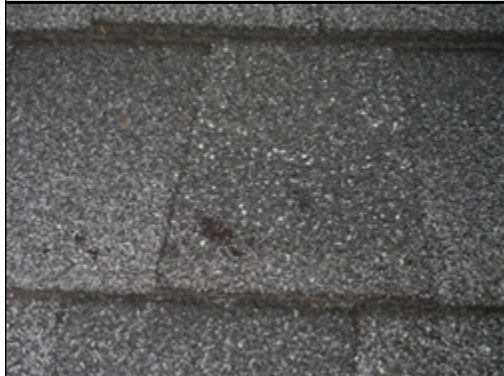
**(C1 - 1.10 ) All Accessible Areas**

-damaged shingle

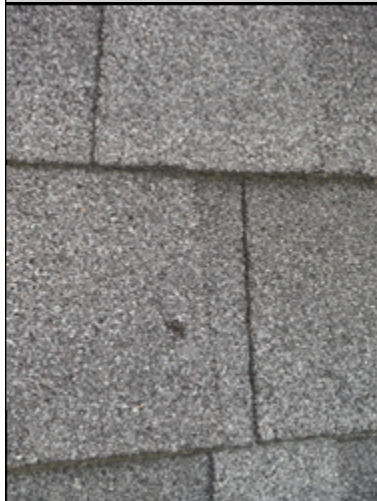
**(C1 - 1.11 ) All Accessible Areas**

-damaged shingle

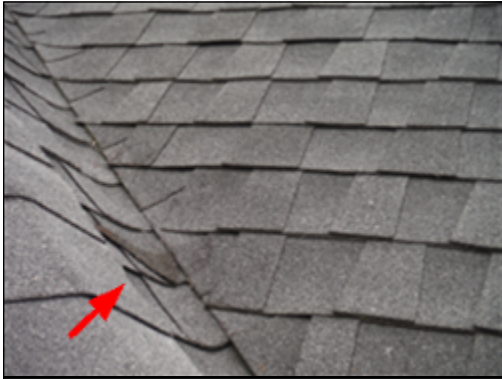
**(C1 - 1.12 ) All Accessible Areas**

-damaged shingle

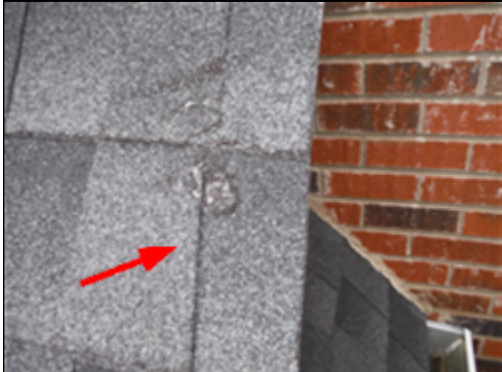
**(C1 - 1.13 ) All Accessible Areas**

-damaged shingle

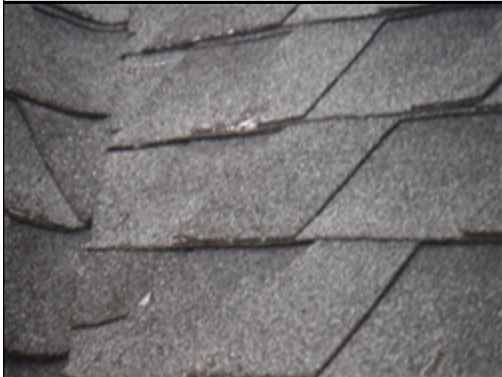
**(C1 - 1.14 ) All Accessible Areas**

-damaged shingles

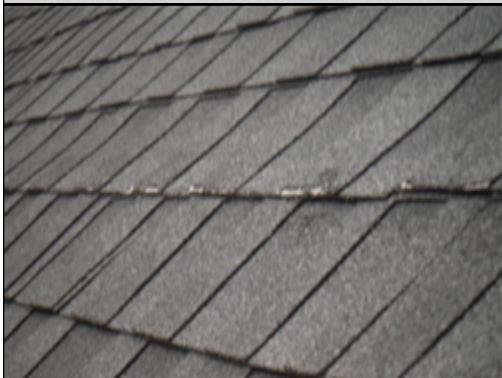
**(C1 - 1.15 ) All Accessible Areas**

-damaged shingles

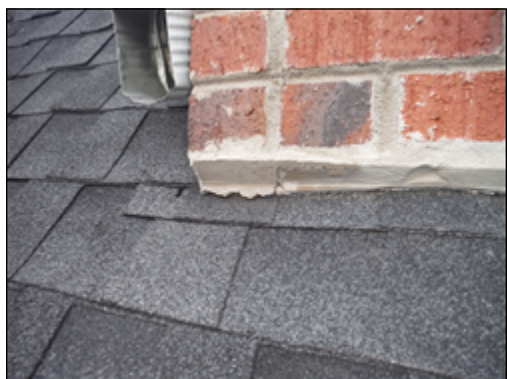
**(C1 - 1.16 ) All Accessible Areas**

The brick mortar joint for the brick veneer is in contact with the shingle surface. There is no visible flashing observed where the brick veneer contacts the shingles. Owner disclosure is needed to determine the flashing method used at these locations. If no information is available you should consult with a licensed roofing contractor to determine how the shingles are flashed at the end walls. There is no visible weep system at the bottom of brick veneer that contacts the roof. The weep system prevents water and condensation buildup behind the brick veneer. A licensed general contractor should be consulted for complete evaluation to determine the significance of this concern and repair as necessary.

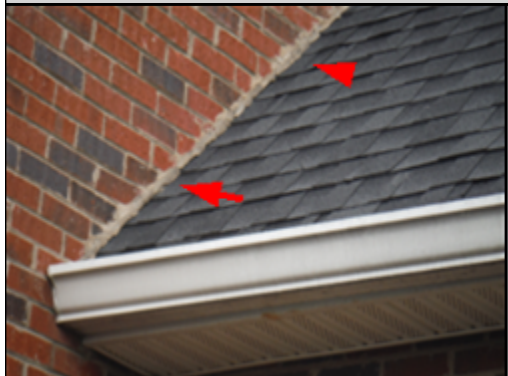
**(C1 - 1.17 ) All Accessible Areas**

-flashing not visible at gable end wall

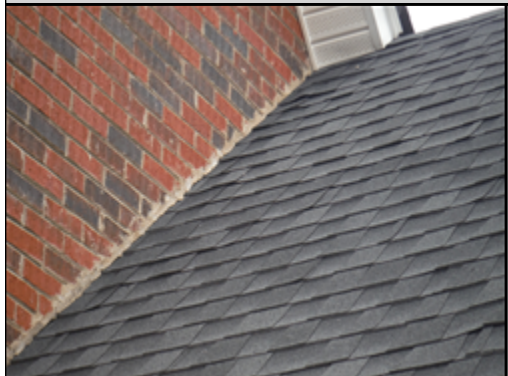
**(C1 - 1.18 ) All Accessible Areas**

Several shingles on the roof surface were noted to be scuffed or damaged. The damage appears to be from construction traffic. When the shingle's surface protective ballast is damaged, they can prematurely age, split and crack. A licensed roofing contractor should be consulted for a complete evaluation of the roof covering to replace damage shingles to ensure the durability of the roof covering system.

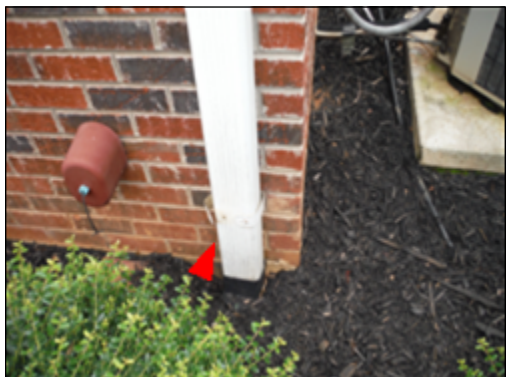
**(C2 - 1.1 ) All Accessible Areas**

The strap is loose on the gutter downspout on the left rear corner of the home. This needs repair to properly secure the down spout. A maintenance or repair man is needed to reattach the strap.

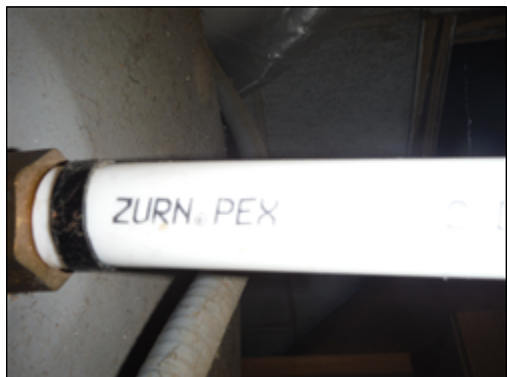
## (D1 - 1.1 ) All Accessible Areas

Some of the visible plumbing lines in this home are plastic PEX with QPEX metal fittings manufactured by the Zurn Corporation. These plumbing fittings are the subject of a consumer class action lawsuit and settlement due to fitting failures related to dezincification. After years of consumer complaints, the Zurn Corporation has acknowledged that it has seen an increased number of premature failures and leaks in its QPex fittings. A licensed plumbing contractor should be consulted for a complete evaluation of the plumbing system to determine the general condition of the plumbing distribution and supply lines, the significance of this concern, and make necessary repairs. The client should visit the class action settlement website for more information, [www.PlumbingFittingSettlement.com](http://www.PlumbingFittingSettlement.com).

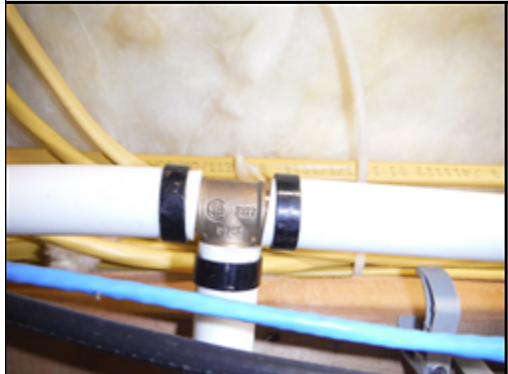
**(D1 - 1.2 ) All Accessible Areas**

-Q-pex fitting

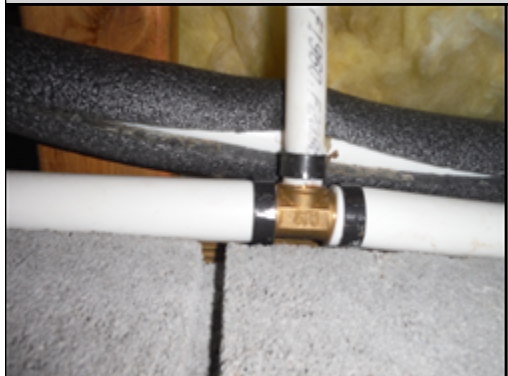
**(D1 - 1.3 ) All Accessible Areas**

-Q-pex fitting

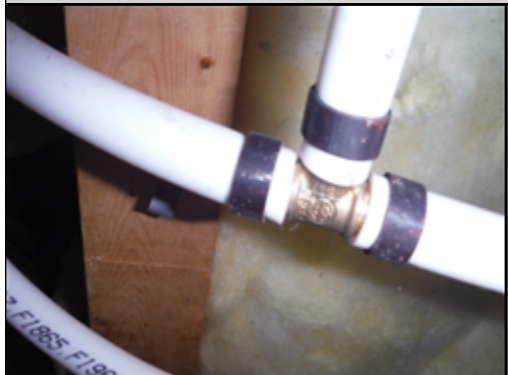
**(D1 - 1.4 ) All Accessible Areas**

-Q-pex fitting

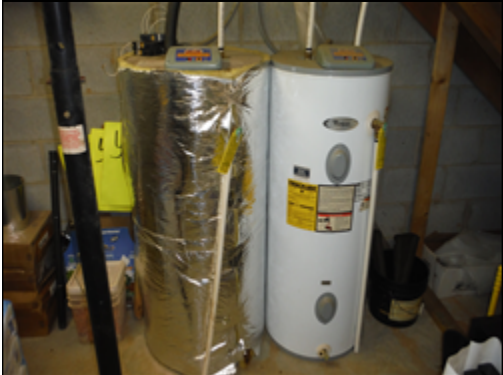
<p>The home has two hot water heaters installed. One is a holding tank and is connected to the working hot water heater. A Thermal expansion tank was not found. Thermal expansion tanks are safety devices designed to relieve pressure on the plumbing system when the home has a public water source that does not have a bladder tank. The hot water system for this home does not have an expansion tank. Expansion tanks have been recommended since 2002 and provide an added level of safety to the hot water system of a home. A licensed plumbing contractor should be consulted to evaluate the system and determine the need for a an expansion tank.</p>

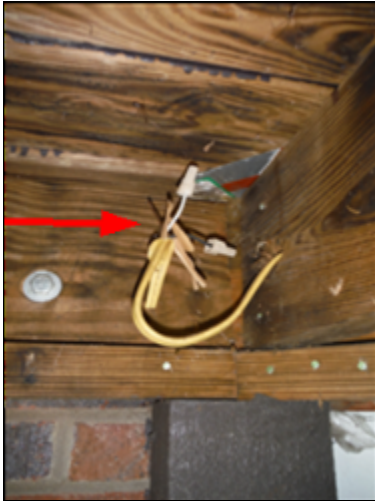
There is a disconnected wire noted under the deck. Disconnected wires should be removed or properly terminated. The disconnected wires leaves electrical conductors exposed and in a hazardous condition. Also, a wire in the crawlspace has the protective covering removed where it passes through the floor. Electrical concerns should be considered fire and safety issues and repaired as soon as possible. The electrical systems and components are in need of a complete evaluation and repair by a licensed electrical contractor.

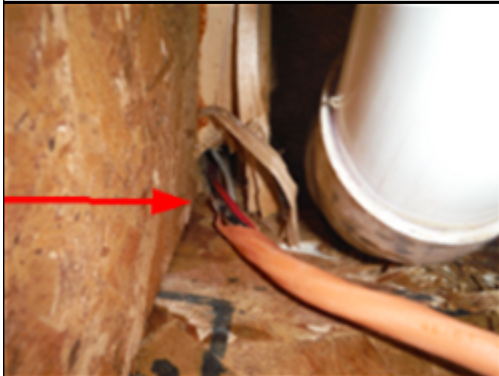
**(E4 - 1.2 ) Exterior/Interior**

-cover off of wire where it passes through the floor

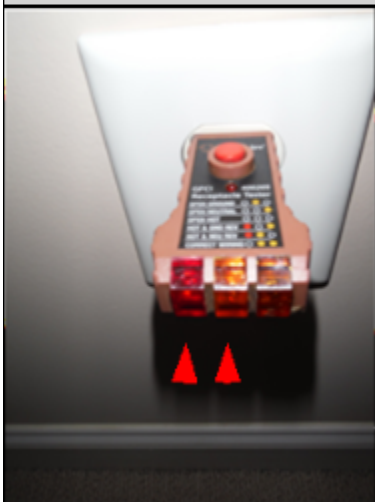
**(E5 - 1.1 ) interior**

The receptacle located in the upstairs exercise room tested as reversed polarity. Polarization provides an extra safety feature to prevent electrical shock hazards and property damage. A licensed electrical contractor should be consulted for a complete evaluation to determine the significance of this concern and make necessary repairs to correct defects and prevent safety hazards.

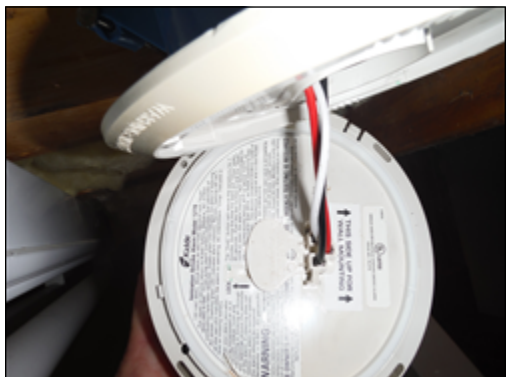
**(E5 - 1.2 ) interior**

One of the smoke detectors located in the basement was older than 7years old. A properly functioning smoke detector is vital to the safety of a home. Smoke detectors should be replaced or updated every 5 to 7 years and batteries changed annually. Testing/replacement prior to purchase is recommended.

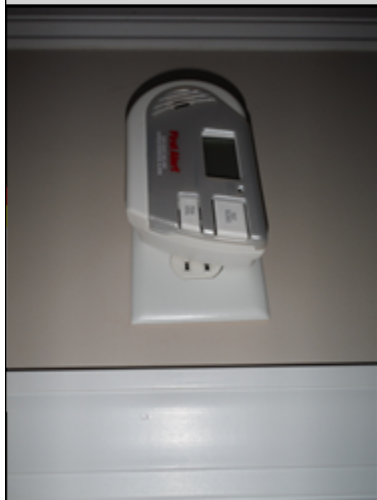
### **(E5 - 2.1 ) interior**

As part of the our standard of practice, the inspector must report the absence or presence of a permanently installed carbon monoxide detector in all homes with garages or fueled appliances. Please note that your report reflects the absence of a permanently installed carbon monoxide detector. All homes with gas appliances, garages, or fireplace should have a carbon monoxide detector as protection to prevent possible carbon monoxide poisoning. A properly functioning CO detector is vital to the safety of a home with gas appliances. Installation is recommended.

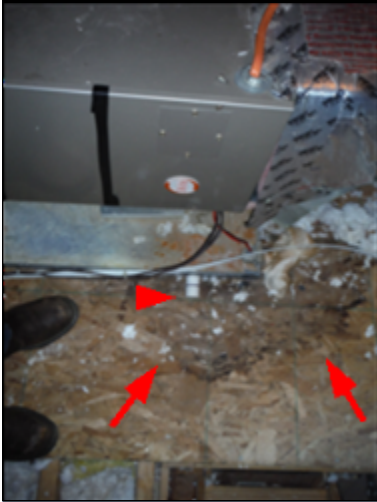
<p>On the upstairs air handler in the attic the AC system drain pan does not have a drain pipe extended to exit condensate water if the pan fills up. Water stains on the floor at the pan suggest that at times condensation leaks out on the attic floored area. Improper drainage of the condensate water can result in system and property damage. A HVAC contractor should be consulted for a complete evaluation and to make necessary repairs to ensure safe, reliable, and proper operation of the HVAC system.</p>	
<b>(G2 - 1 ) Cooling Unit Served: Cooling Unit #1#2</b>			
<b>Cooling: Distribution Systems (Descriptions):</b>

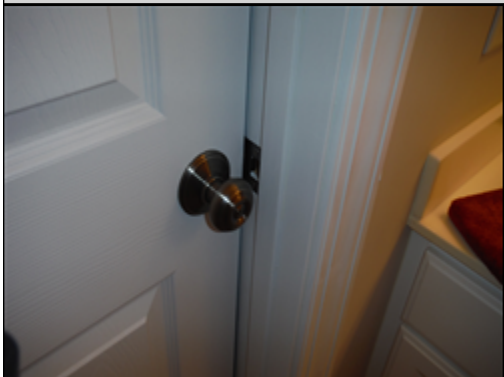
#### (H3 - 1.1 ) Bathroom #2

One of the upstairs bathroom door knobs does not engage good with the strike plate The door/lock needs repair to ensure that the door latches properly. A general repair specialist should be consulted for evaluation and repair.
